HOME INSPECTION REPORT

**11164 N. River Vue Cir.
Biloxi, Ms. 39532**

Report Number:
06212005

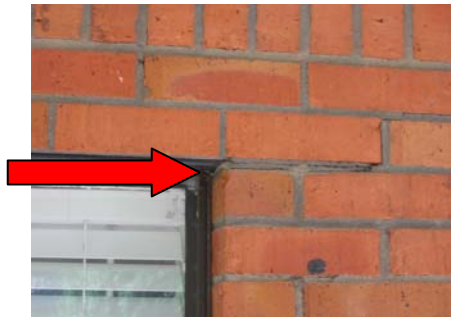
- **Monitor:** An exterior wall crack above a lintel (in effect, a beam supporting the brickwork above an opening in the wall) suggests that the lintel may be marginally adequate on the front wall on the first floor window. This condition is not uncommon.

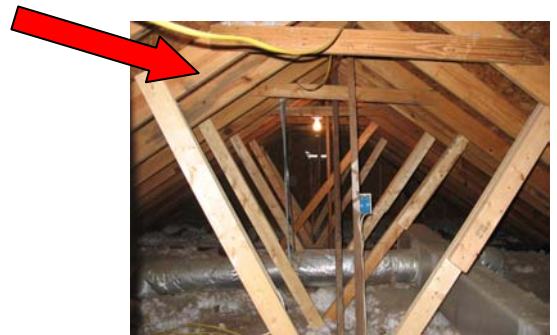
- **Improve:** Ideally, collar ties (horizontal members running between each rafter, near their mid-span) should be provided for all rafters. Collar ties help to resist rafter sag. Installation is usually very simple.

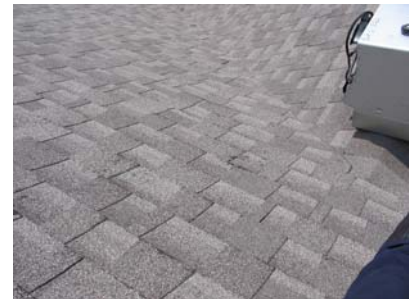
- **Monitor:** The roofing is considered to be in good condition. This roofing is wearing at uneven rates. The sides of the roof (South Slope) that are most exposed to the sun’s light are wearing more quickly than the more shaded areas. Repair or replacement of deteriorated roofing may be needed in some areas, prior to the entire roof covering requiring replacement.

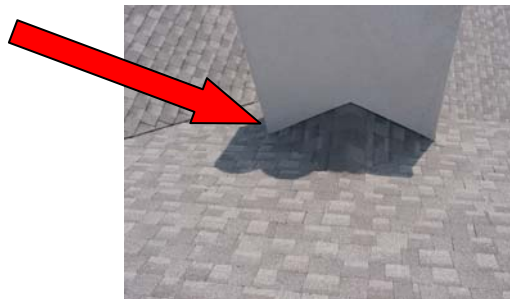
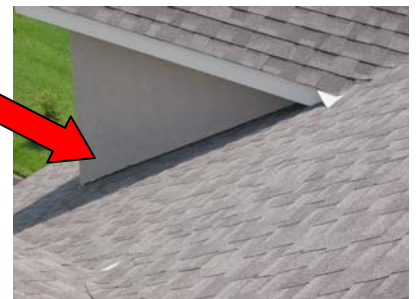
- **Monitor:** The flashing on the dormer should be carefully monitored. The proximity and configuration of this flashing is extremely vulnerable to leakage.
- **Monitor:** The flashing at the rear slope near the chimney should be carefully monitored. The proximity and configuration of this flashing is extremely vulnerable to leakage.

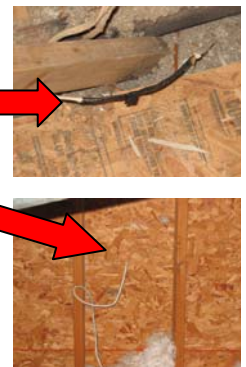
- **Safety Issue:** Improper electrical connections should be improved in the attic. All electrical connections should be made inside junction boxes fitted with cover plates.
- **Improve:** Abandoned wiring in the service box should be removed or appropriately terminated.
- **Improve:** Abandoned wiring in the attic should be removed or appropriately terminated.
- **Improve:** Wiring in various locations should not touch hot air ductwork or hot water piping.
- **Improve:** All junction boxes in the attic should be fitted with cover plates, in order to protect the wire connections.
